Clarksville School Building Assessment  
ALBANY COUNTY SHERIFF'S OFFICE

1. INTRODUCTION

The County of Albany has commissioned WCGS Architects, Huston Engineering and WEB Engineering to perform an Assessment of the former Clarksville Elementary School located at 58 Verda Avenue in Clarksville, New York. The purpose of the Assessment is to provide the Albany County Sheriff's Office with a description of the condition of the building and its systems prior to the Sheriff's Office purchase of the facility from the Bethlehem Central School District. The Assessment has investigated conditions in the following categories:

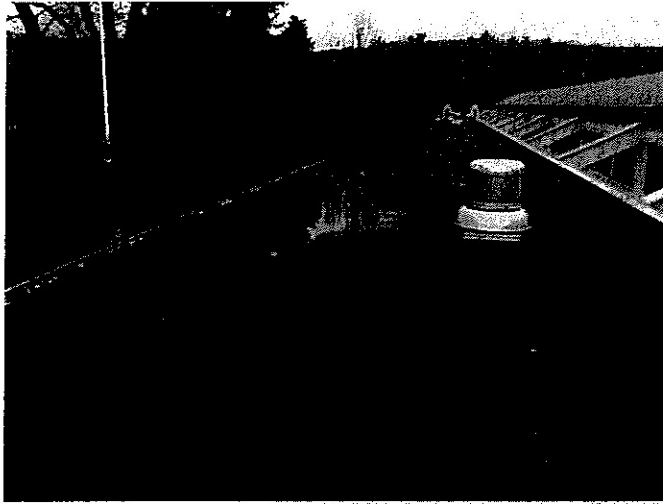
- .1 Multiple instances of ponding were observed, indicating insufficient slope to drains or scupper outlets. Separation of the roof membrane from the substrate was observed, in the form of areas of loose membrane bubbling from the substrate. Occupants described recurring leaks in Room 15, which contains telecommunications equipment for the town court. Insulation above the ceiling /below the roof in this area has been removed, which may result in additional heat loss and cause additional water infiltration.

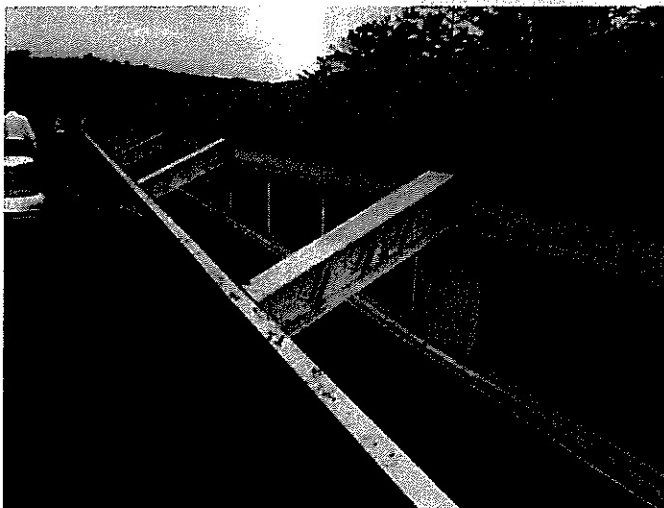
- .2 The roof membrane at the clerestory windows on the south side of Rooms 8, 9, 10, 11, 12 and 13 has a very short (approximately 3 inch) vertical return below the windows. Building occupants report that snow from the roof above the clerestories slides down on the roof below, piling up and causing water infiltration through the windows if the snow is not manually cleared.

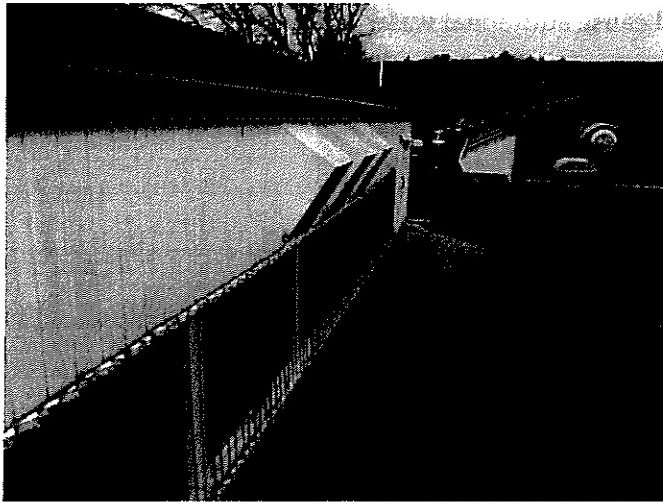
- .3 Building occupants report repeated instances of leaks around the skylight in the passage space adjacent to Room 30. This is possibly another area with insufficient vertical return of the roof surface, which allows snow against the wall to infiltrate as water.

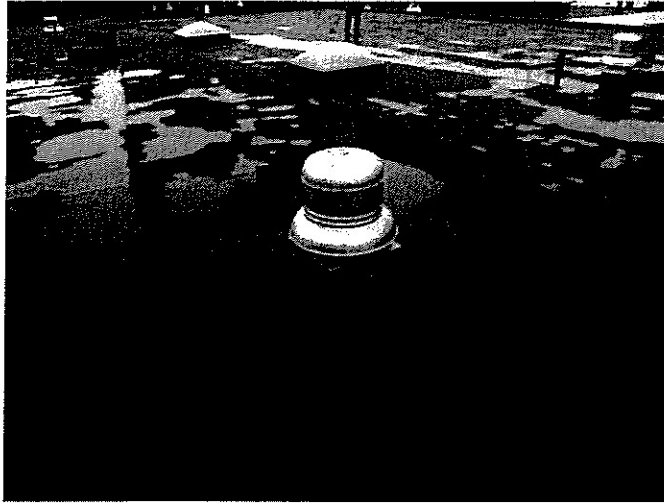
- .4 On the 1968 wing there were multiple shallow areas of ponding, indicating insufficient slope to the drain. The membrane appears to have maintained its bond to the substrate on this portion of the building.

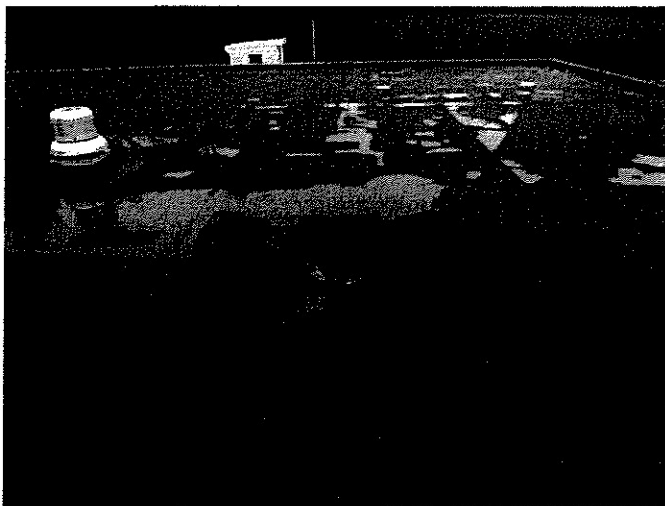
- .5 This roof area is served by only one roof drain, making it susceptible to overflow or leaks if the drain becomes clogged and is not maintained. Building occupants reported that multiple adjacent tall pine trees dropping their needles on to the roof have caused drain blockages previously, and the 2015 Facilities Plan recommended annual clearing of the roof drain. When this roof is replaced, consideration should be given to providing at least one additional roof drain.

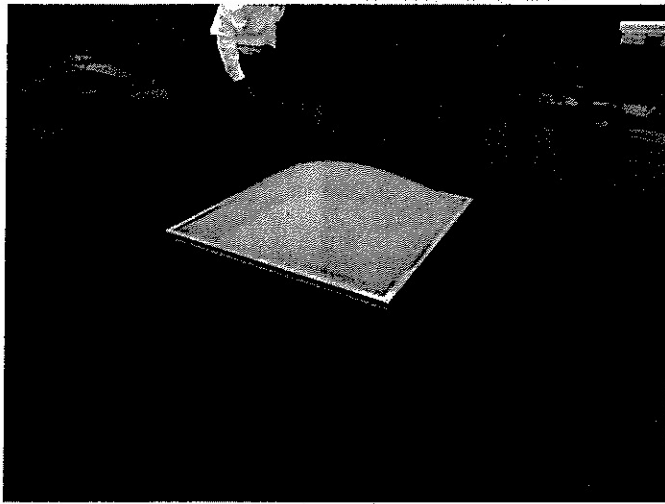
- .6 There are two overflows scuppers along the north and south edges of the roof. However, these are located so far to the west of (and much higher than) the drain that the roof is more likely to overflow onto the adjacent lower roof than through the relief scuppers. When this roof is replaced, scuppers should be located to adequately protect the roof.
- .7 This roof area contains two skylights, which building occupants indicate have been an occasional source of leaks. Observation of the skylights found water visible below the glazing at the top of the curb, indicating that there is no path for escape from the assembly once it has infiltrated.

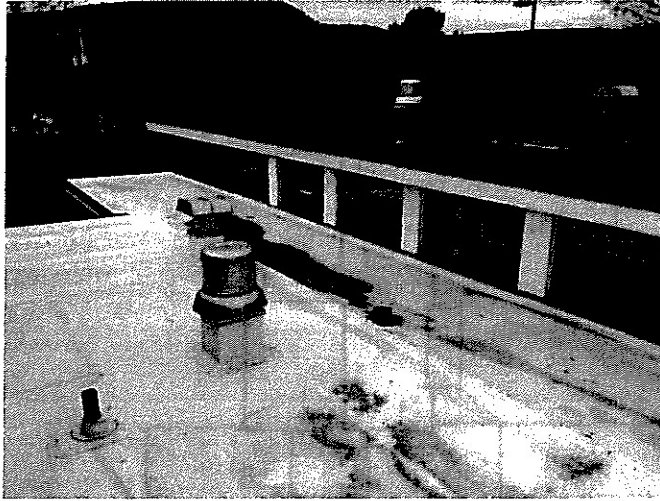
- .8 There are areas of significant ponding, indicating insufficient slope to the roof drains above Rooms 27 and 28 and the adjacent passages. The roof surface is spongy in several location, indicating that the substrate below has been degraded due to water infiltration.

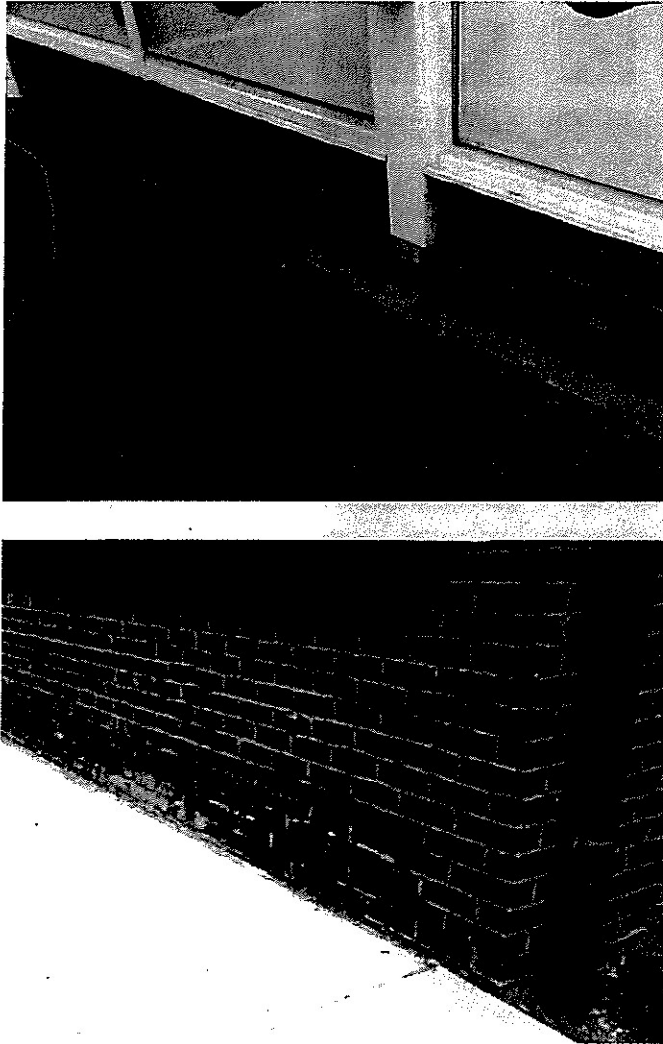
- .1 Numerous instances of deteriorated brick and mortar on the 1948 and 1954 sections were identified. Brick and mortar in these areas will require replacement for at least several courses above the ground. This deterioration was listed in the 2015 Facilities Plan, and appears to be caused by three conditions:

Salting of adjacent walking and driving surfaces:

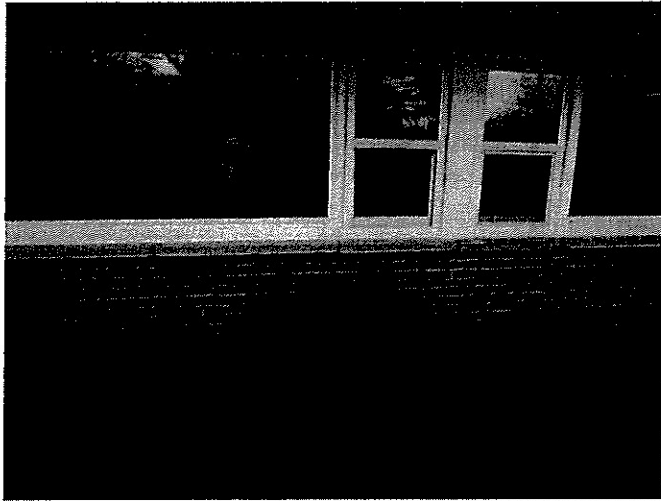
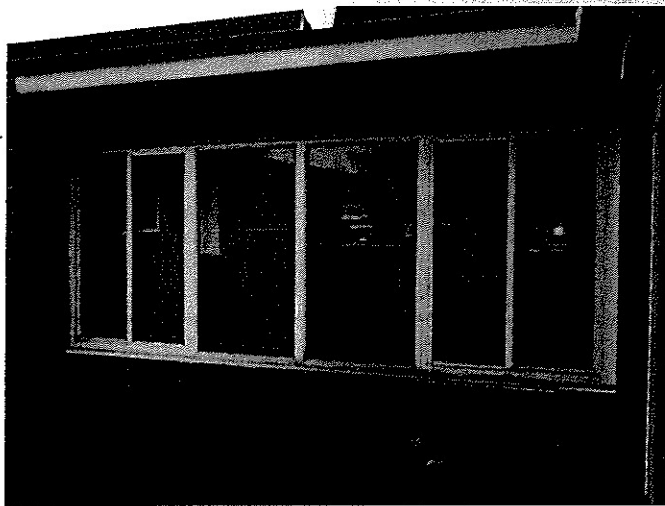
Water from roof drains or scuppers falling uncontrolled onto ground mounted splash blocks and splashing onto the adjacent brick wall surfaces. Erosion from the splashing and freeze / thaw action of the splashed water is likely responsible for the resulting deterioration. Brick in these areas may be salvageable if cleaned. The mortar will at a minimum require repair.

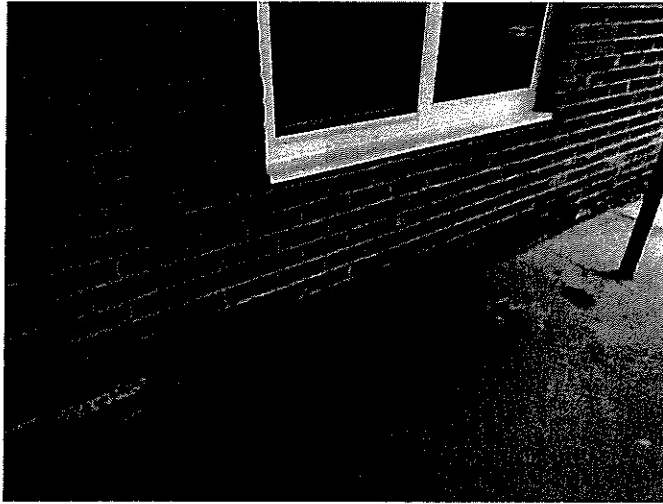
Incorrect slope of the concrete walkway below the main entrance directs water toward the brick wall, allowing it to pool against the brick and cause damage from freeze / thaw action. Brick and mortar in these areas will require replacement for at least several courses above the ground.

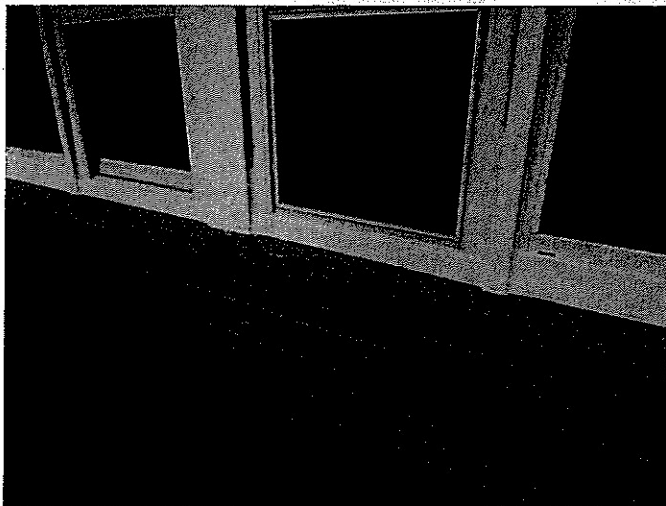
- .2 Precast concrete sills below numerous windows on the 1948 wing are cracking and breaking apart, with fracturing of one sill exposing the steel reinforcing bar. This damage is referenced in the 2015 Facilities Plan. Replacement of the damaged concrete sills will be required at these locations.

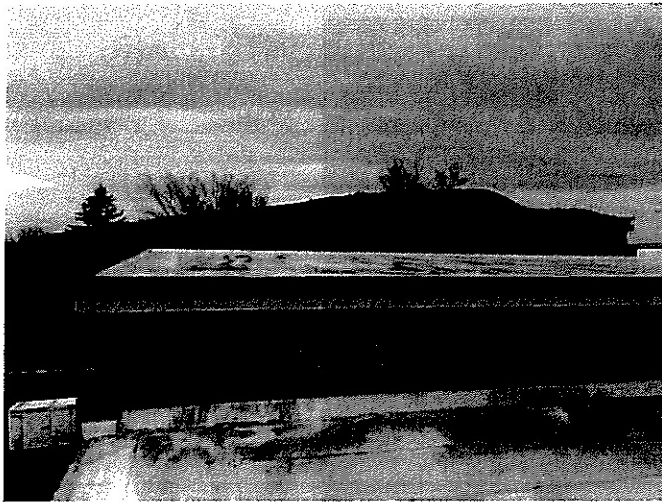
- .3 The EIFS wall surface on the north wall of the 2006 addition above the adjacent roof is stained and may have mold growth present. This may be due to the lack of sun on this exposure combined with moisture from snow accumulating on the roof below. This is the area of the roof leak identified in 2.1.9.

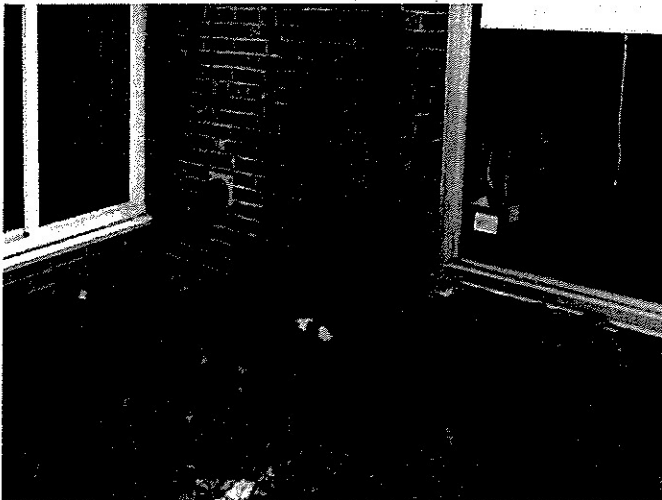
- .4 Finish grade outside of Room 25A/25B/24A/22/20 extends above finished floor height. This condition may allow for moisture infiltration through the exterior masonry wall.

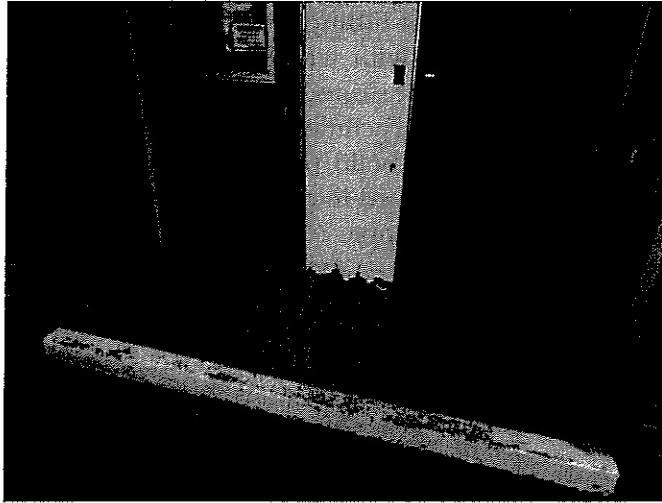
- .5 Metal panel between exterior doors on the west side of the 1968 addition is corroded at grade, and will likely need replacement.

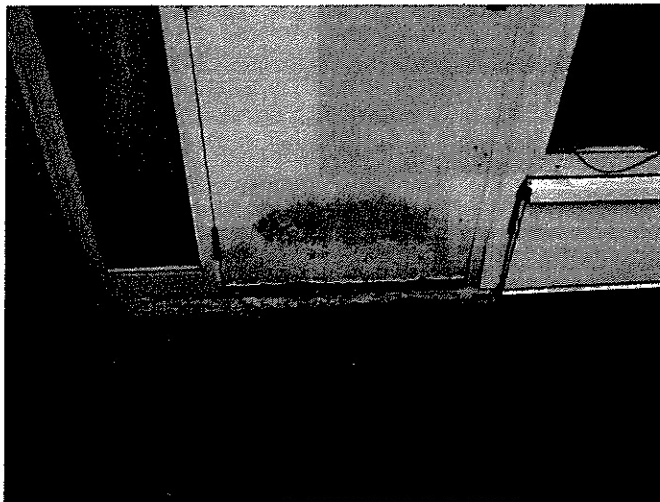
- .1 Metal doors to the exterior from Rooms 8, 9, 10, 11, 12 and 13 are corroded at their base. This may be partly a function of uncontrolled water hitting the ground from the roof edge above. Building occupants report no current issues with water infiltration at the doors. Ground mounted concrete pads at these locations have shifted to slope toward the building at these doors. These issues were identified in the 2015 Facilities Plan. If doors are no longer required from these rooms, consider replacement with solid panels. If doors are required consider replacement with FRP doors similar to those used in other locations of the building, and the installation of new concrete pads with proper slope.

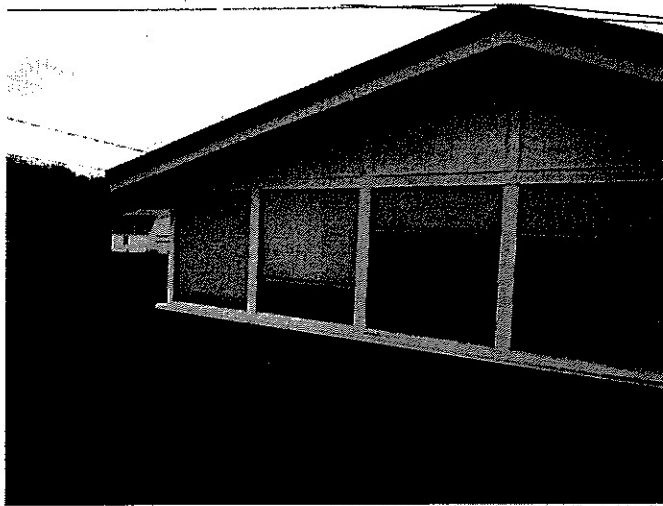
- .3 Some exterior windows at Room 14 are original single pane glass units, which provide poor thermal performance. A portion of the windows have had new insulated glass units set into the existing frames with sealant. Thermal performance of the non-thermally-broken frames will continue to be poor. Exterior steel frames have been painted, and paint has begun to peel from the frames.

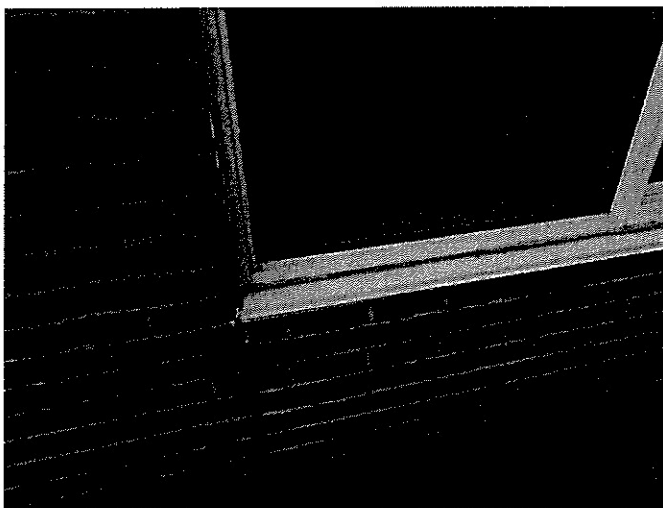
- .1 Sealant joints at opening perimeters and control joints show evidence of deterioration. Consider recaulking of all exterior joints to prevent moisture infiltration. Analysis of existing caulking material must be performed prior to removal to determine the presence of hazardous materials.

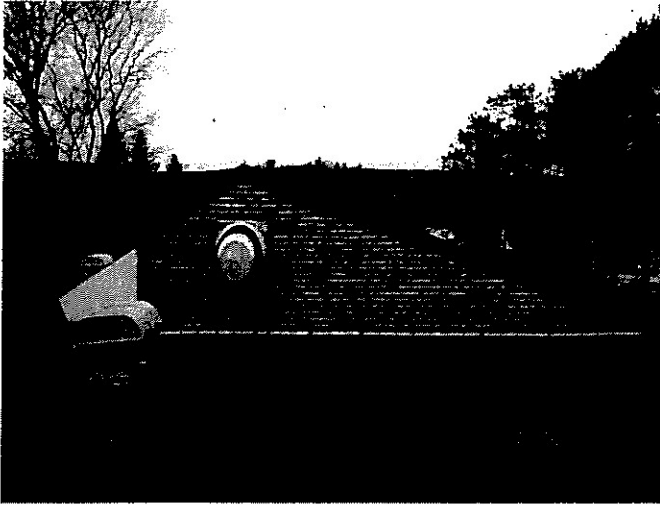
- .2 A few cracks were observed in the exterior brick surfaces of the two gable ends of the pitched roof sections of the original 1948 building. This allows moisture to penetrate the exterior surface, causing continuing deterioration, and should be repaired.

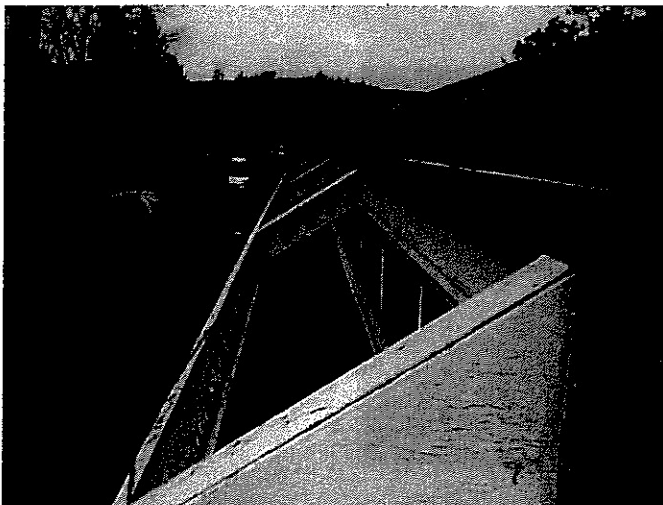
- .3 Rust and peeling paint was observed on the exterior steel surfaces of the 1948 Building clerestory sunshade framing. Deterioration appears minor but will continue to progress. Scraping and repainting is recommended.

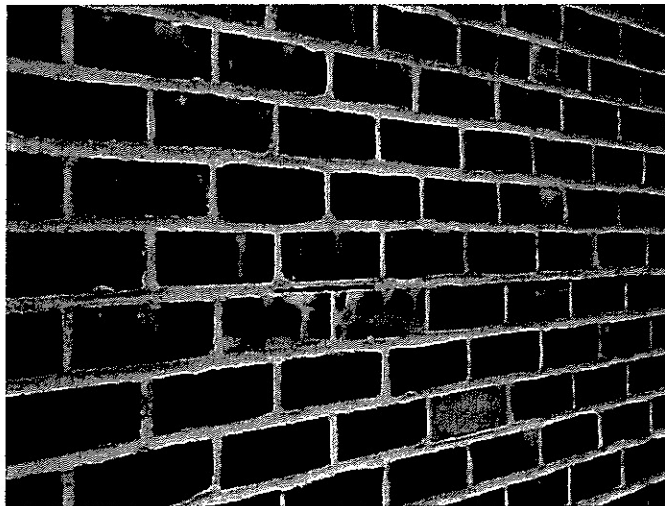
- .1 What appears to be exposed and rusting horizontal joint reinforcing was observed at a few locations in the west exterior wall of the 1968 Addition. This is likely the result of water infiltrating the wall surface and joint reinforcing being installed too close to the face of the wall. This should be addressed to prevent further deterioration.

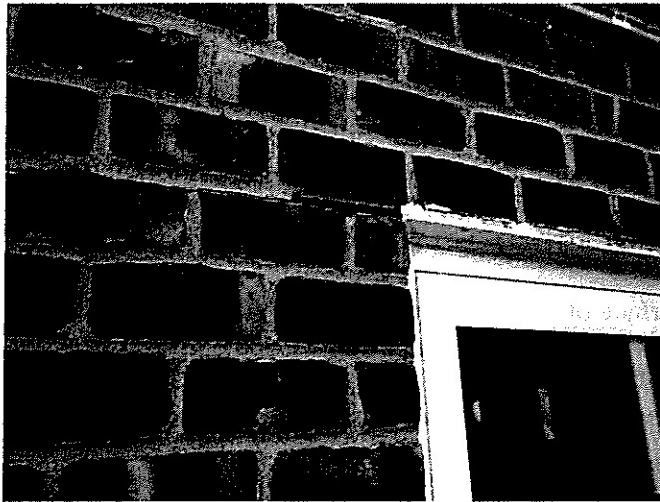
- .2 Mortar is missing at the ends of a few steel lintels located over exterior openings at the Original 1948 Building and the 1954 Addition. Rust has started to form on the lintels in places. The steel surfaces should be treated, and the mortar replaced to slow the deterioration.

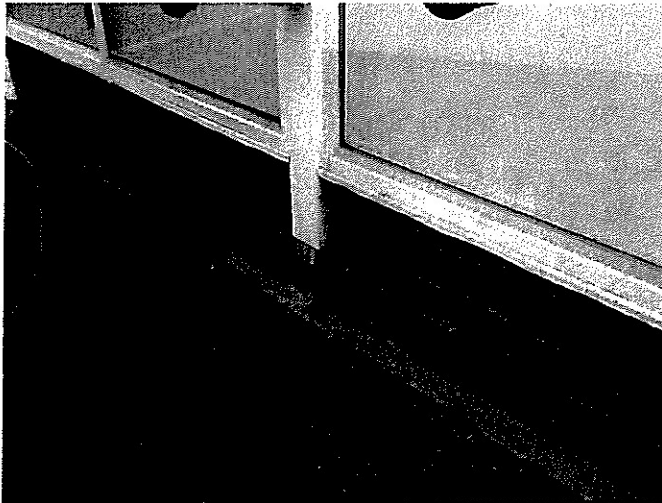
3. Significant deterioration of the lower sections of the west wall of the 1954 Addition Gymnasium is present in the form of eroded mortar joints in the first few courses of brick and what appears to be significant rusting of the outer surface of the structural steel columns which support the roof structure. The full extent of this damage requires further investigation and reinforcement of the steel columns is likely needed. The assessment Project Team is preparing a scope of work to perform removals necessary to better understand the degree of deterioration and development of documents describing any required repairs. Scope of work and estimate provided under separate cover.

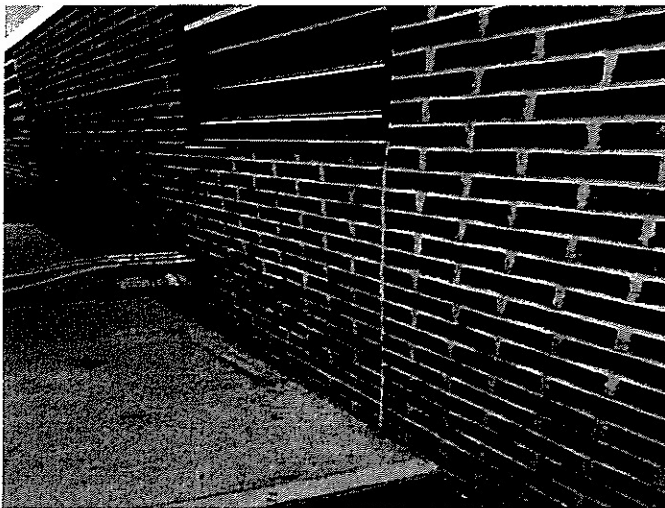
4. A vertical crack in the brick veneer was observed on the west wall of the 2006 Boiler Room Addition. The cause is unknown but appears to be the result of possible impact to the wall. This should be repaired to prevent water infiltration.

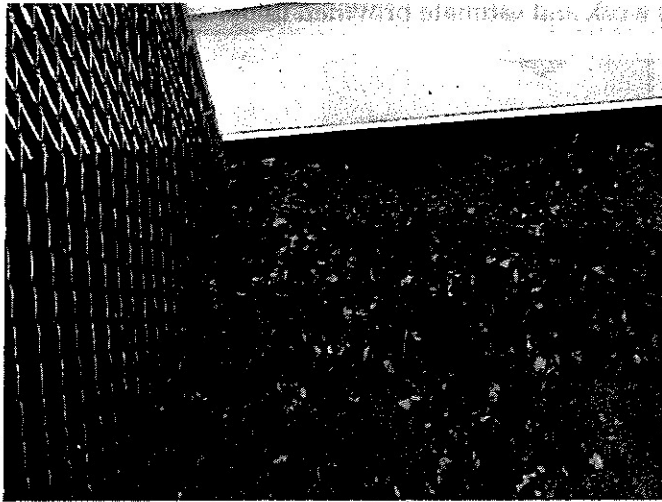
5. What appears to be broken foundation masonry allowing water to enter the pipe trench located along the north wall of the classroom wing of the Original 1948 Building was observed at several locations. Additionally, exterior grade along this wall is high and nearly level appearing to direct water towards the building. A continuous stream of water was observed flowing into the boiler room located at the end of this trench. The foundation wall should be repaired and sealed, and water should be directed away from the building.

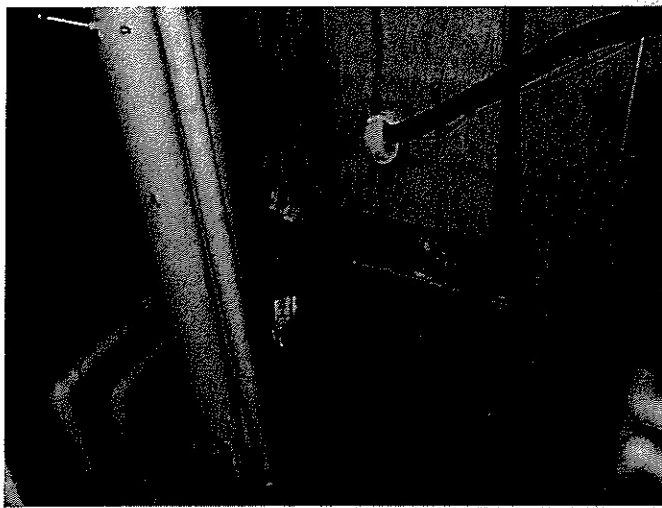
- 4 Evidence of significant water infiltration is present in the Original 1948 Boiler Room Pit. Water was actively entering the building at the time of our visit, and the interior surface of the concrete masonry walls are starting to deteriorate. This is a location where exterior grade is above finished floor and where the previously noted pipe trench ends. This is not currently a significant structural concern but could become more concerning if the water infiltration is not addressed.

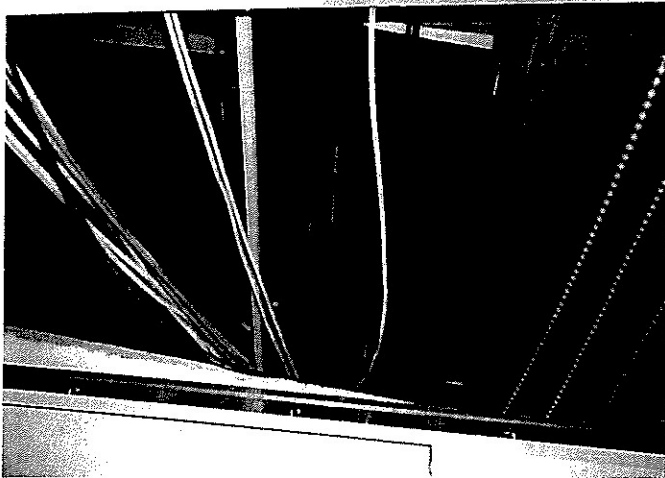
- .5 It appears that modifications to the roof structure in the form of removed blocking and altered joist framing has occurred above the Server Room located at the east end of the Original 1948 Building. These modifications should be investigated further to ensure they have not weakened the roof structure.

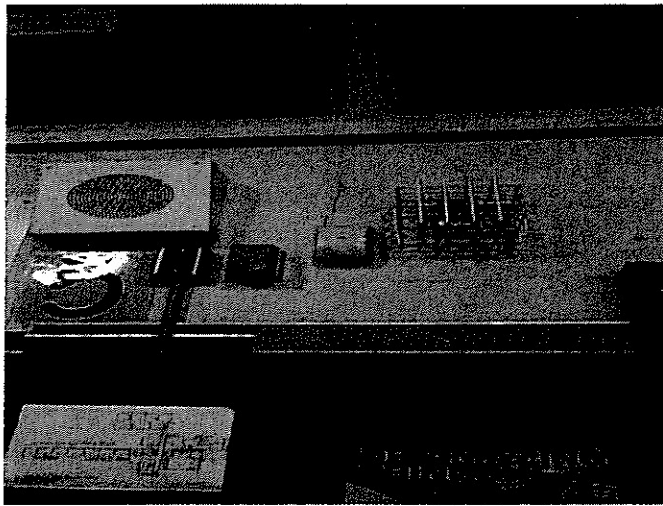
- .6 A few vertical cracks were observed on the interior face of the concrete masonry walls of the 1954 Addition Gymnasium. Currently these do not appear to represent significant structural concerns and may be the result of the lack of control joints in these walls (common for this age of structure). These should be monitored and addressed if changes occur in the future.

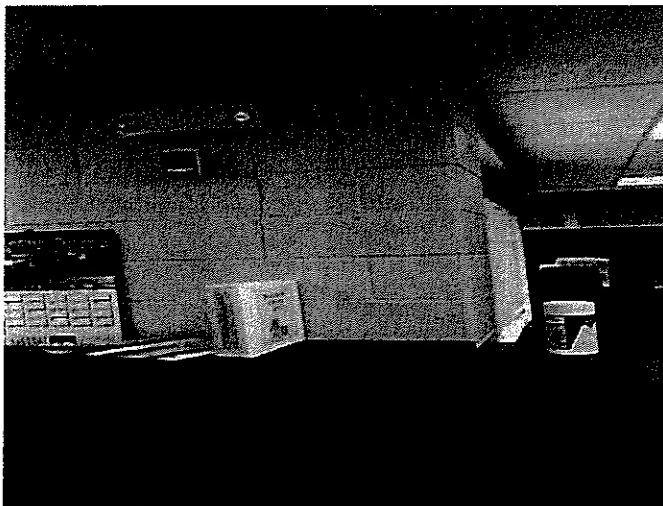
- .7 Two vertical cracks were observed in the concrete masonry wall at the joints between the 1954 Addition and the small 2006 Addition in Room 20. The 2006 Addition drawings call for this to be a soft joint (allowing movement) but it appears a fully mortared joint was installed. While unsightly this does not appear to represent a significant structural concern. Routing out of the mortar and installation of a soft joint would be a cosmetic option.

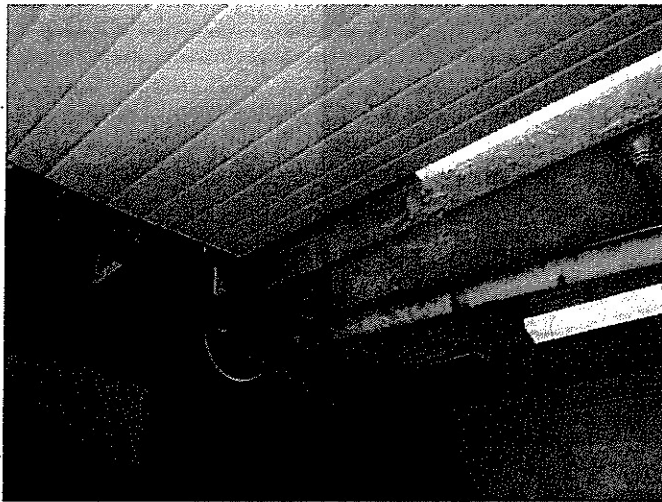
- .8 Evidence (peeling paint and stains) of past roof leaks possibly from the adjacent roof drain were observed in the ceiling of the 1954 Addition Garage. The structure was not exposed to allow direct observations. Given the type of construction (wood joists and steel beams) and the fact that this location is directly adjacent to a higher roof (Gymnasium) with snow drift potential we suggest additional investigation (ceiling removal) of this area of roof to determine if any of the structural framing has deteriorated.

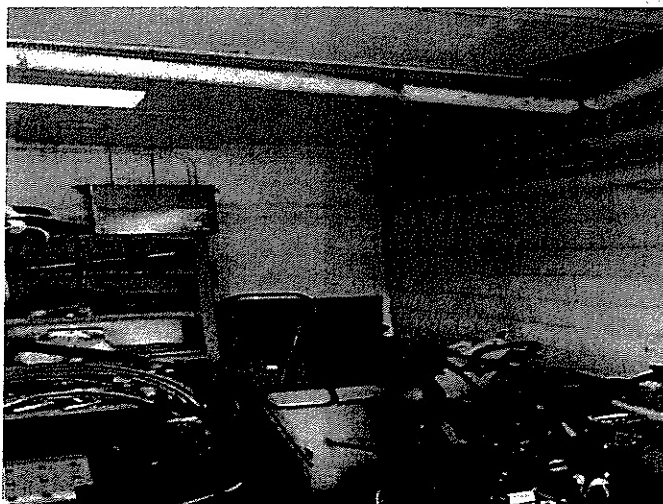
- .9 A vertical crack is present in masonry wall at the southwest corner of the 1954 Addition Garage (Room 24A). Currently this does not appear to represent significant structural concerns and may be the result of potential foundation movement or differential movement between the buildings. This should be monitored and addressed if changes occur in the future.
