Clarksville School Building Assessment  
ALBANY COUNTY SHERIFF'S OFFICE

1. INTRODUCTION

The County of Albany has commissioned WCGS Architects, Huston Engineering and WEB Engineering to perform an Assessment of the former Clarksville Elementary School located at 58 Verda Avenue in Clarksville, New York. The purpose of the Assessment is to provide the Albany County Sheriff's Office with a description of the condition of the building and its systems prior to the Sheriff's Office purchase of the facility from the Bethlehem Central School District. The Assessment has investigated conditions in the following categories:

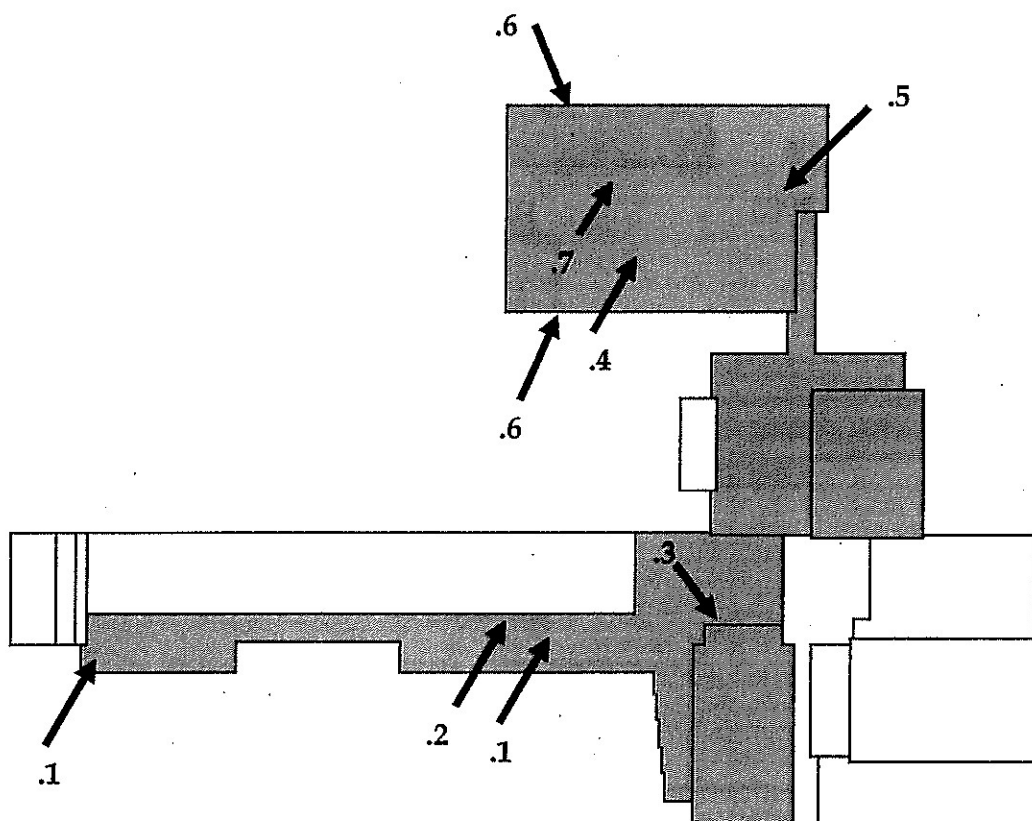
- .1 Multiple instances of ponding were observed, indicating insufficient slope to drains or scupper outlets. Separation of the roof membrane from the substrate was observed, in the form of areas of loose membrane bubbling from the substrate. Occupants described recurring leaks in Room 15, which contains telecommunications equipment for the town court. Insulation above the ceiling /below the roof in this area has been removed, which may result in additional heat loss and cause additional water infiltration.

- .2 The roof membrane at the clerestory windows on the south side of Rooms 8, 9, 10, 11, 12 and 13 has a very short (approximately 3 inch) vertical return below the windows. Building occupants report that snow from the roof above the clerestories slides down on the roof below, piling up and causing water infiltration through the windows if the snow is not manually cleared.

- .3 Building occupants report repeated instances of leaks around the skylight in the passage space adjacent to Room 30. This is possibly another area with insufficient vertical return of the roof surface, which allows snow against the wall to infiltrate as water.

- .5 This roof area is served by only one roof drain, making it susceptible to overflow or leaks if the drain becomes clogged and is not maintained. Building occupants reported that multiple adjacent tall pine trees dropping their needles on to the roof have caused drain blockages previously, and the 2015 Facilities Plan recommended annual clearing of the roof drain. When this roof is replaced, consideration should be given to providing at least one additional roof drain.

- .6 There are two overflows scuppers along the north and south edges of the roof. However, these are located so far to the west of (and much higher than) the drain that the roof is more likely to overflow onto the adjacent lower roof than through the relief scuppers. When this roof is replaced, scuppers should be located to adequately protect the roof.
- .7 This roof area contains two skylights, which building occupants indicate have been an occasional source of leaks. Observation of the skylights found water visible below the glazing at the top of the curb, indicating that there is no path for escape from the assembly once it has infiltrated.

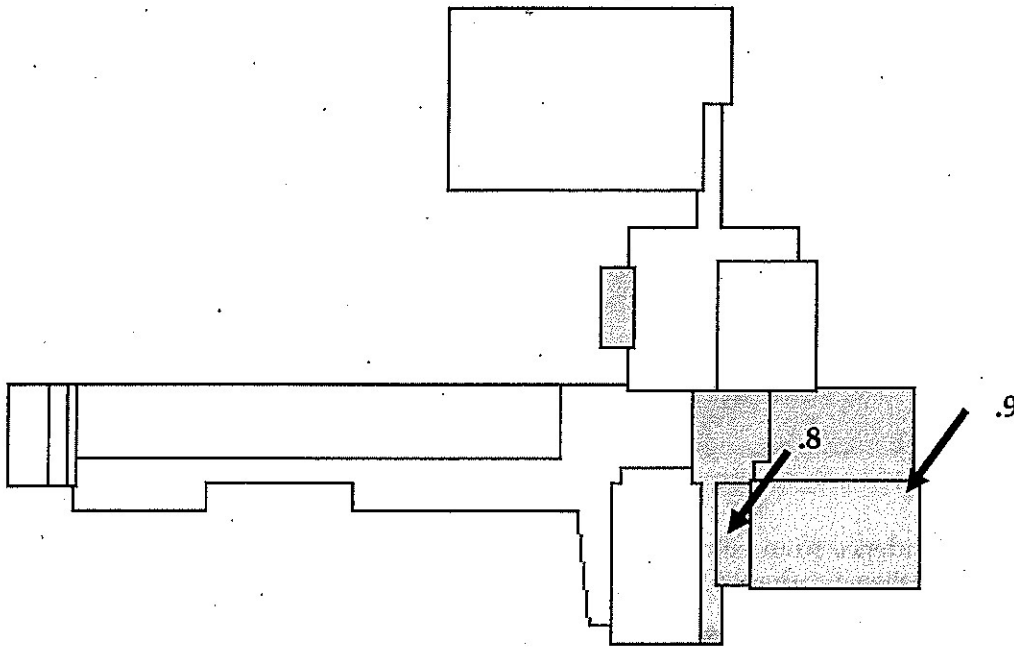
- .8 There are areas of significant ponding, indicating insufficient slope to the roof drains above Rooms 27 and 28 and the adjacent passages. The roof surface is spongy in several location, indicating that the substrate below has been degraded due to water infiltration.

- .9 There is evidence from below of an active roof leak above the northeast corner of Room 42 and the southeast corner of Room 41.

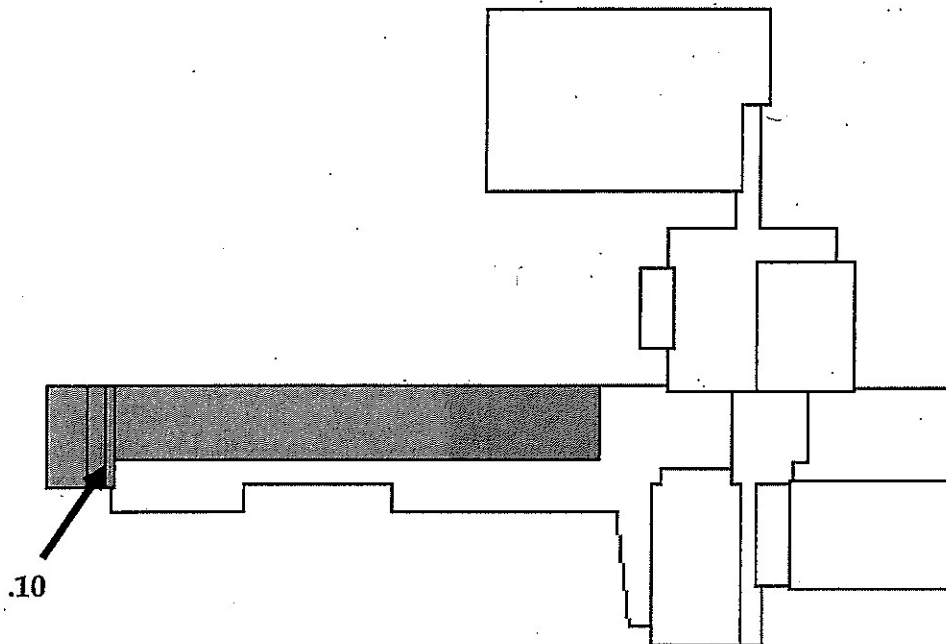
- .10 Building occupants reported recurring leaks above Room 14 at the intersection with the 1948 wing. Where the sloped roof intersects with the flat roof the membrane has detached from the substrate, preventing water from reaching the drain, which may be causing ponding and allowing for water infiltration.

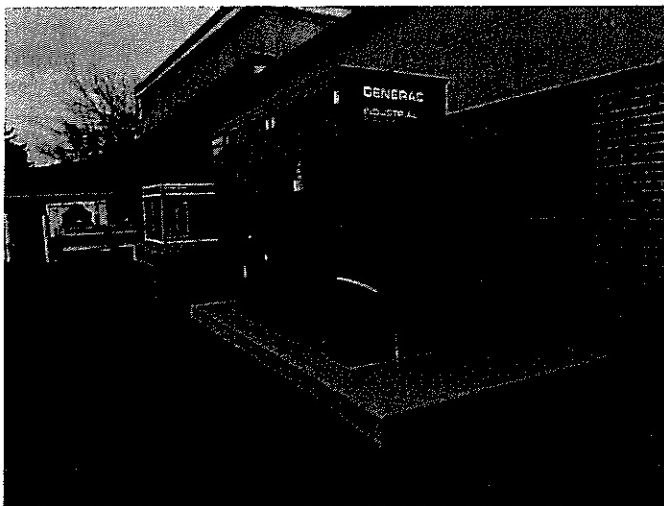
- .4 The building staff indicated that the generator has been called on and has successfully operated the building in the past during power failures.
- .5 As indicated in the narrative above, the peak building demand over the past 12 months was 72 kVA, so there is a level of comfort that the generator has the capacity to operate the building in its present condition. As the building occupancy increases, and air conditioning is added, the generator will likely be undersized similar to the remainder of the existing electrical service.

- .6 It is certainly feasible to have a generator power only selected loads in the building. For example, in this climate, general comfort air conditioning which is a large demand, is often not powered by the generator. Conversely, building heating is a relatively minor power demand and would be important in this climate.
